Manhole Inspection Summary

Manhole # S39E2_002MH

Insp Date: **12/11/07 2:03 PM**

Location Address: **4200 Audrey Ave**

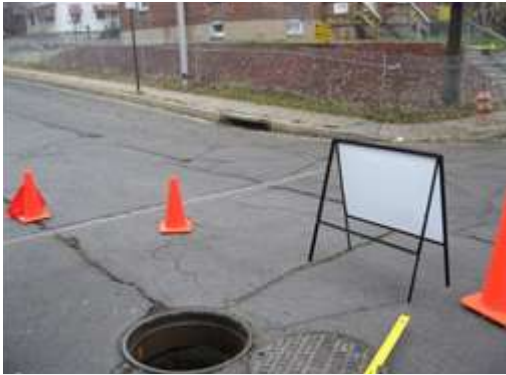
Location View

Audrey & 5th St intersection

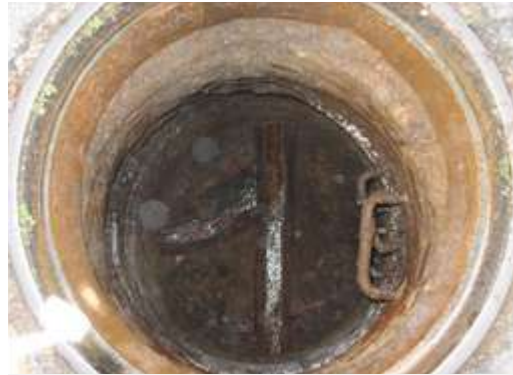
Top View

Count: **6** Missing: **0** ☒ **Corroded**

steps

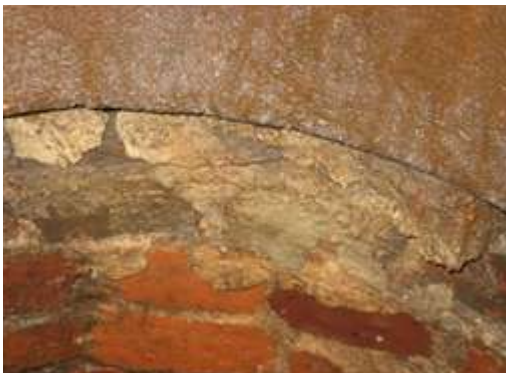
Condition: ☐ Sound ☐ Cracked ☐ Root Intrusion ☒ **Loose Brick** ☐ Deteriorated

Infiltration: ☐ None ☐ Joint ☐ Cracks ☒ **Mortar** ☐ Roots ☐ Wall

mortar & loose brick under frame

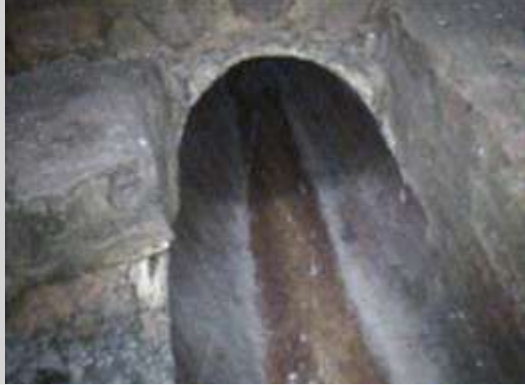
12 O'Clock Outflow

8 in. Circular Gravity Sewer
Pipe Out @ 12 O'Clock

Pipe Height: **10.8** (in.) Rod and Bar (Angled)
Pipe Material: **Clay** ☐ Pipe Lined
Invert Depth: **10.18** (ft.) Flow Characteristics: **Fast**
Deposits: ☒ None ☐ Mud ☐ Sludge ☐ Debris ☐ Grease
Silt Depth: (in.) Deposits Extent:
Infiltration: **None** Pipe Seal Cond: **Sound**

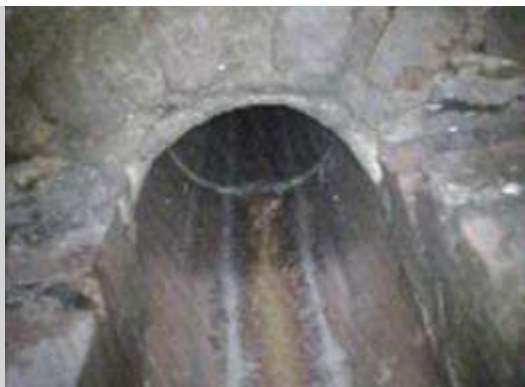
6 O'Clock Inflow

8 in. Circular Gravity Sewer
Pipe In @ 6 O'Clock

Pipe Height: **10.8** (in.) Rod and Bar (Angled)
Pipe Material: **Clay** ☐ Pipe Lined
Invert Depth: **10.10** (ft.) Flow Characteristics: **Fast**
Deposits: ☒ None ☐ Mud ☐ Sludge ☐ Debris ☐ Grease
Silt Depth: (in.) Deposits Extent:
Infiltration: **None** Pipe Seal Cond: **Sound**

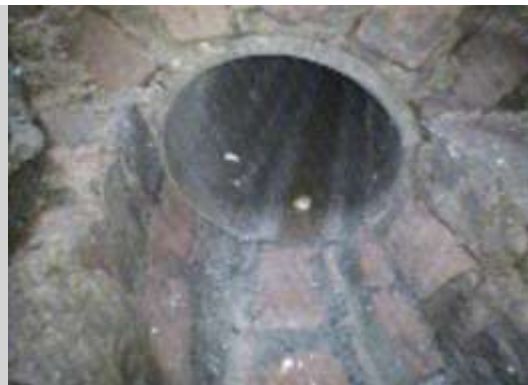
9 O'Clock Inflow

8 in. Circular Gravity Sewer

Pipe In @ 9 O'Clock

Pipe Height: **9.6** (in.) Rod and Bar (Angled)

Infiltration: **None** Pipe Seal Cond: **Sound**
